State of Nevada  
Department of Public Safety  
Division of Parole and Probation  
Campos Office Complex Site  
Facility Condition Analysis

# **CAMPOS OFFICE & PARKING COMPLEX SITE**

215 East Bonanza Blvd.  
Las Vegas, Nevada 89101

**Site Number: 9794**  
**STATE OF NEVADA PUBLIC WORKS DIVISION**  
**FACILITY CONDITION ANALYSIS**

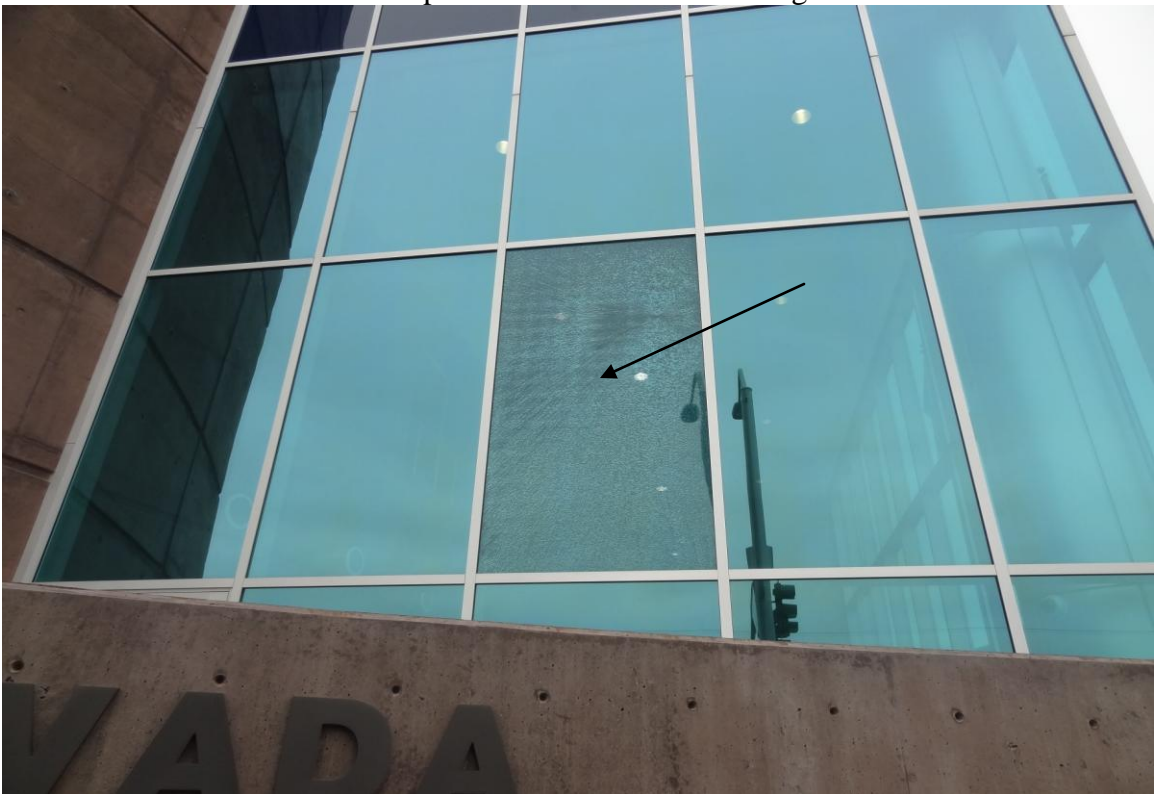
Campos Office & Parking Complex Site – FCA Building #2790  
Description: Shattered glazing panel.

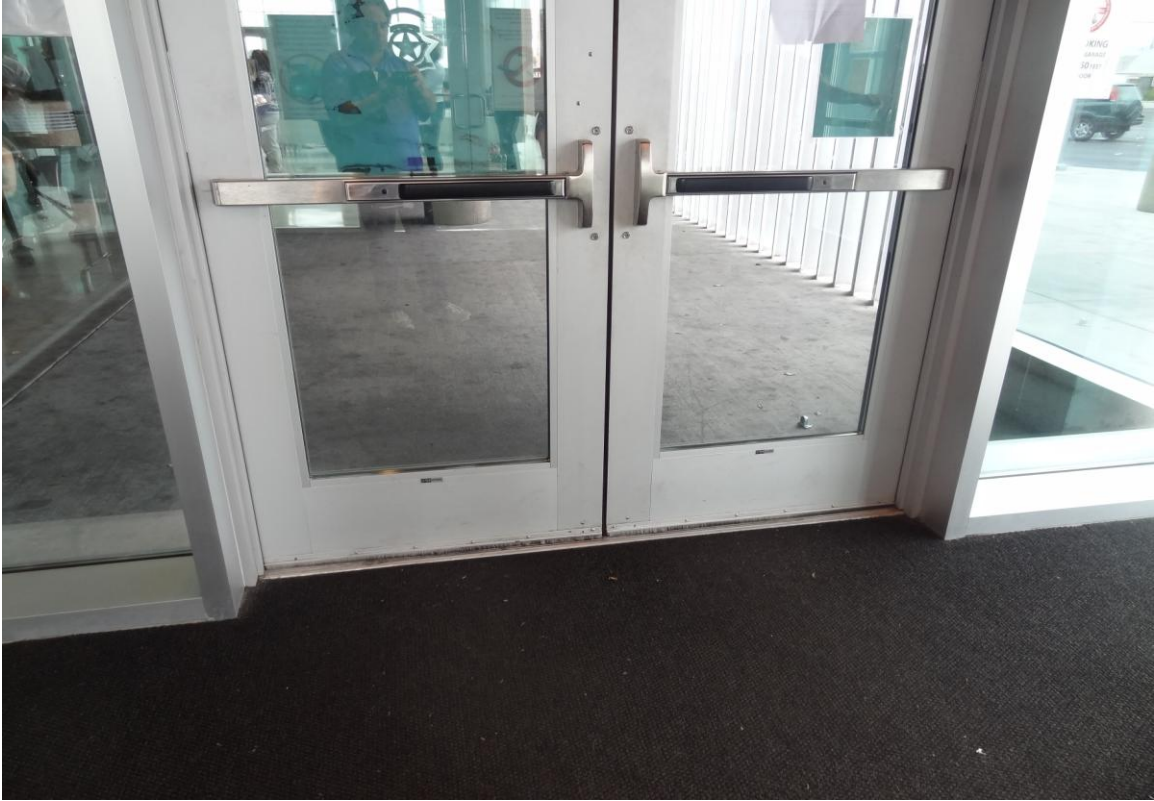
Campos Office & Parking Complex Site – FCA Building #2790  
Description: Main entrance doors with remote unlocking issues.

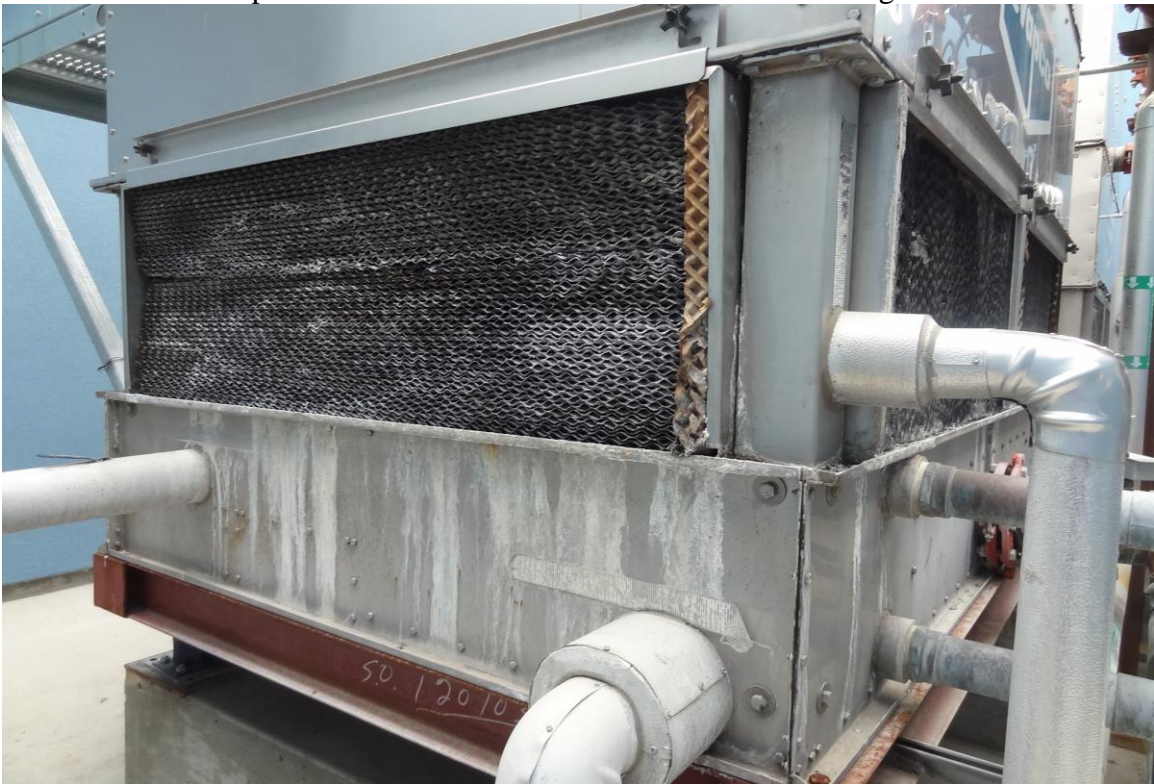
The existing water softening/ treatment systems in the building are currently not operational or are ineffective. Failure of the equipment causes wear and tear on the domestic water supply lines, plumbing fixtures and HVAC equipment. A significant amount of scaling was observed on the cooling towers indicating a problem with the water treatment system. This project would provide for the replacement of the existing water softeners/ treatment systems with new equipment. This project would also provide for a chemical treatment program including an updated chemicals control system, service and employee training provided by a qualified water treatment vendor. The annual maintenance fee charged by the water treatment vendor would be determined after an investigation of the water system is complete. These annual costs are not included in this project cost. For budgeting purposes, a \$12,000 fee is suggested.

Campos Office & Parking Complex Site – FCA Building #2790  
Description: Scale build up on cooling tower.
